Report Number: WI-17-99

**Evaluation of the
GEOWEB and J.K. STRUCTURE
Slope Stabilization Methods**

FINAL REPORT

WisDOT Research Study # 94-18

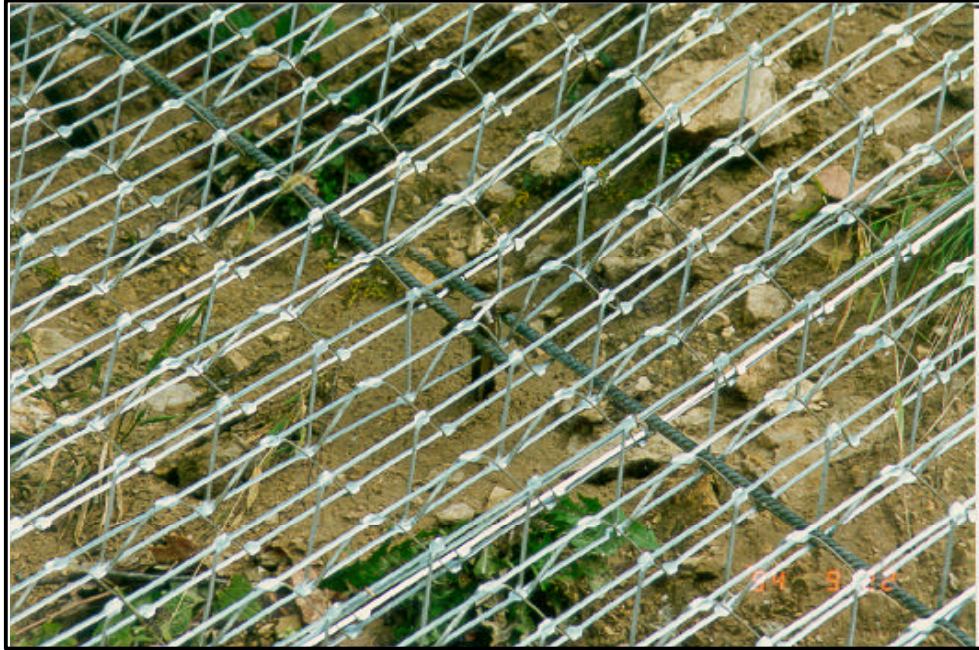
Print 1. Close-up view of the J.K. Structure.

The J.K. Structure, manufactured by J.K. Structure of France, is a 3-dimensional metal skeleton paneling secured to the slope using rebars (Print 1, page 14). The panels measured 1 m x 3 m and were placed at a 45 degree angle across the face of the slope.

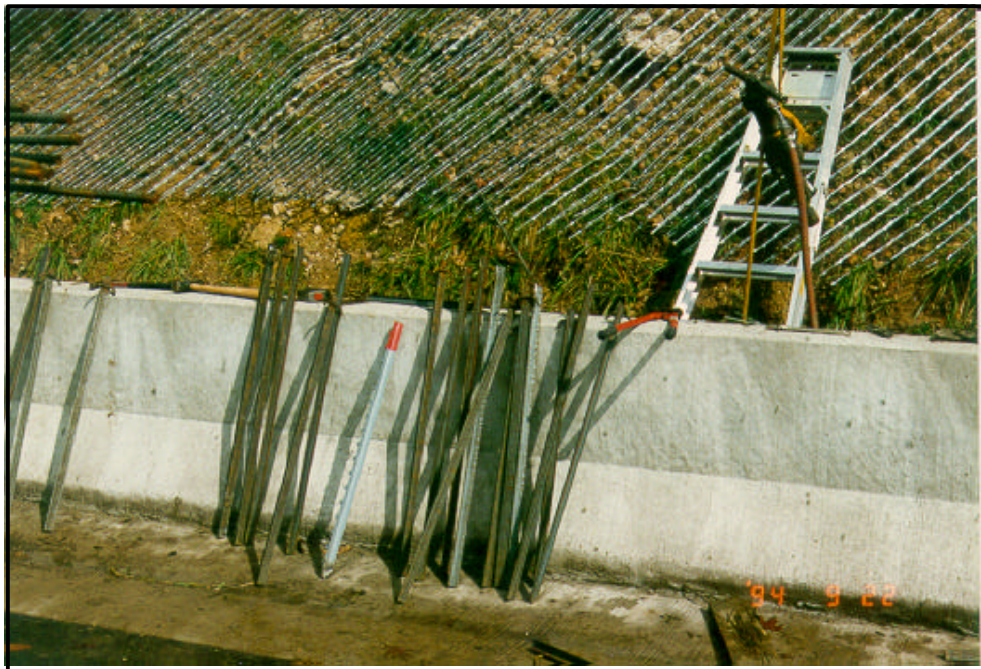
The metal pins furnished were too slim and short, so hooks had to be welded on for added strength. The steep angle and length of the slope made handling the jack hammer difficult, requiring one to two men to operate it and another to hold the stake. The steep angle of the slope required the workers to use ladders to move up and down the slope. Each section of the J.K. Structure had to be carried up separately (later several sections were attached then carried up the slope). Overall, installation was quite laborious and time consuming requiring the use of a boom, a backhoe, ladders and a jack hammer to drive the anchors into the rocky terrain.

Print 2. J.K. Structure in background. Foreground shows anchoring stakes with a “T” welded on the end for securing the structure down.

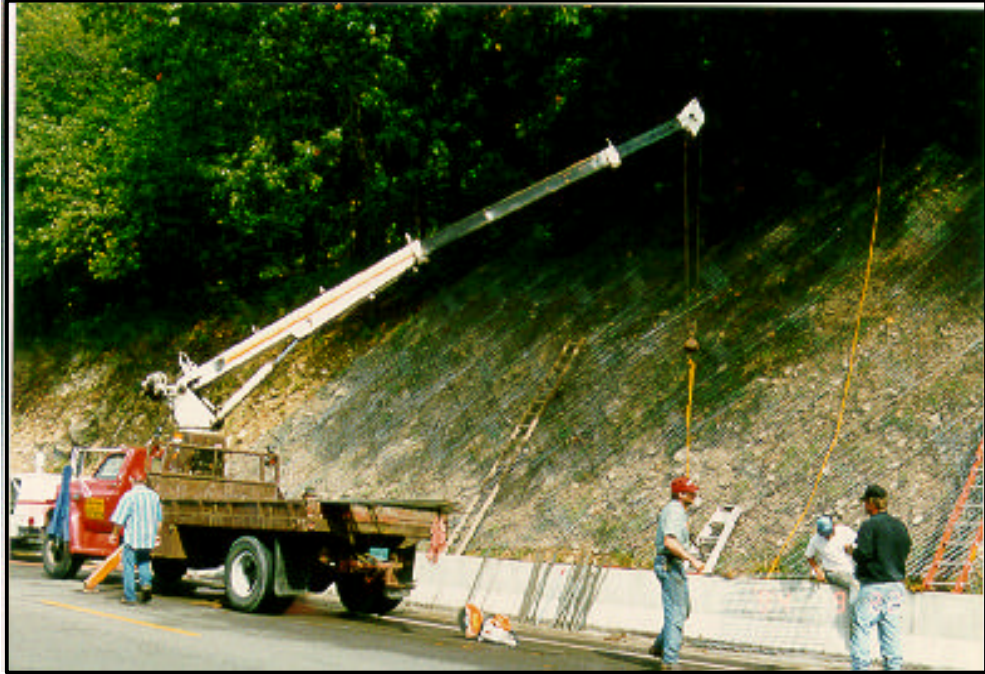
Problems associated with the J.K. Structure installation included difficulty driving stakes, handling of the materials, and the learning curve (what was needed and how to do things). The rocky terrain made driving stakes difficult, necessitating the use of a jack hammer. The metal pins furnished were too slim and short, so hooks had to be welded on for added strength. The steep angle and length of the slope made handling the jack hammer difficult, requiring one to two men to operate it and another to hold the stake. Problems associated with handling the material included sharp edges, requiring the workers to wear gloves. The steep angle of the slope required the workers to use ladders to move up and

Print 3. Installation of the J.K. Structure showing the use of ladders and the boom used to hold the jack hammer.

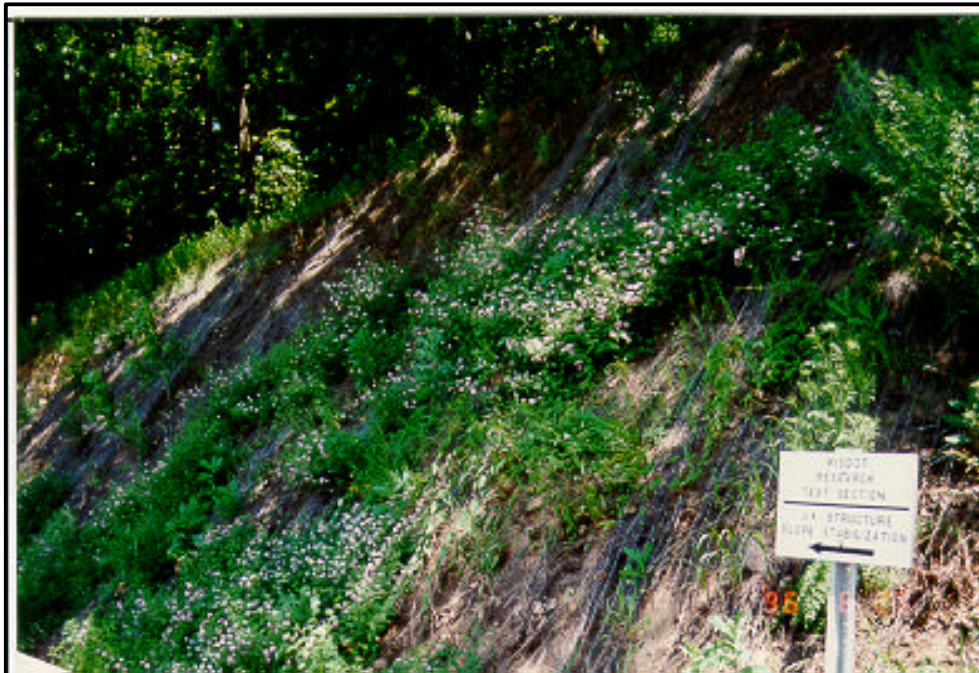
75-80% of this area had no vegetation. There were some areas of crown vetch, a few rye and other grasses and various weeds growing.

Print 6. Vegetation on J.K. Structure June 27, 1996, almost two years after installation.

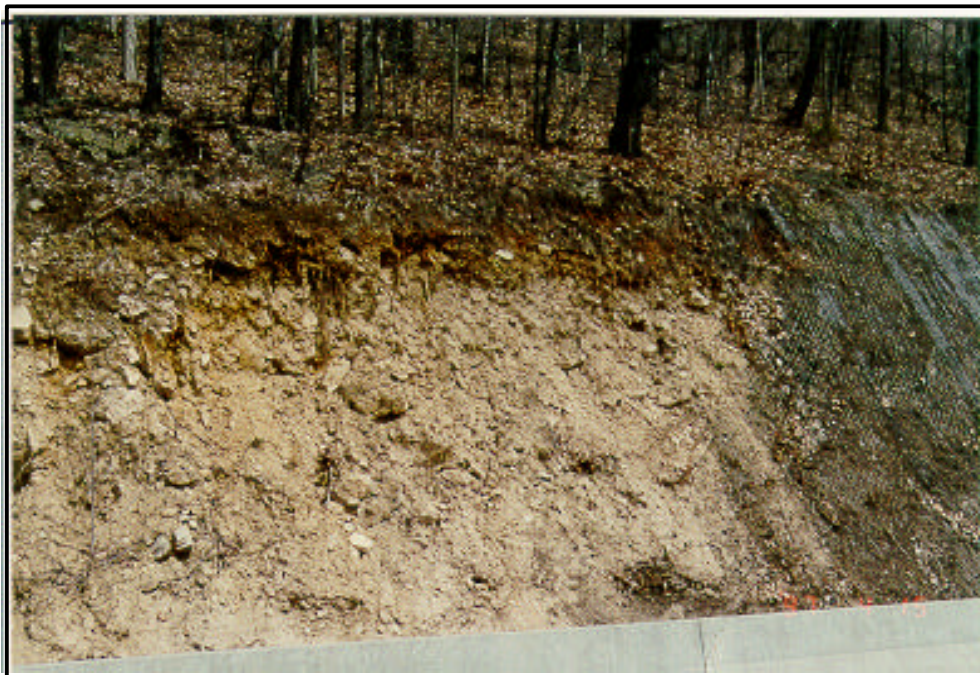
On the untreated area at the north end of the J.K. Structure, an area of erosion was noted. This erosion appeared to be approximately 1.0 ft. deep and stopped at the interface with the J.K. Structure.

On the untreated area at the north end of the J.K. Structure, an area of erosion was noted. This erosion appeared to be approximately 2 ft. deep and stopped at the interface with the J.K. Structure. Material at the bottom of the slope had been cleaned out.

As noted in the 2.5 year inspection, on the untreated area at the north end of the J.K. Structure, an area of erosion was noted. This erosion still appeared to be approximately 2 ft. deep and stopped at the interface with the J.K. Structure. No new material was observed at the bottom of the slope.

Print 8. View of the washed out area to the north of the J.K. Structure. Notice that the washed out area stops at the interface with the J.K. Structure.

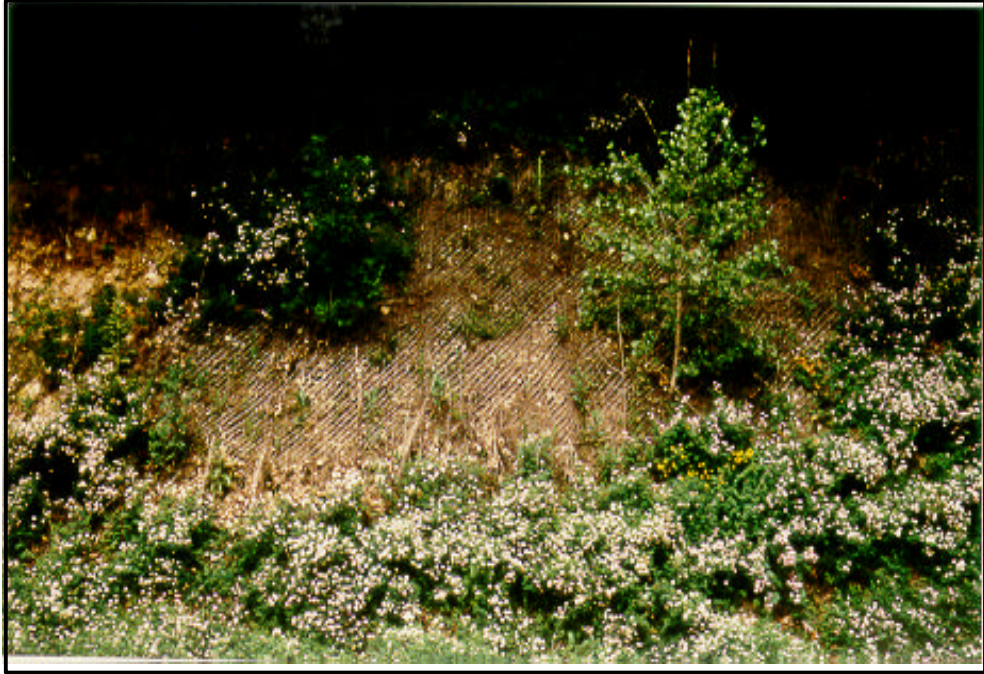
Approximately 50% covered with vegetation.

Print 9. View of the vegetation on the J.K. Structure, June 17, 1998.

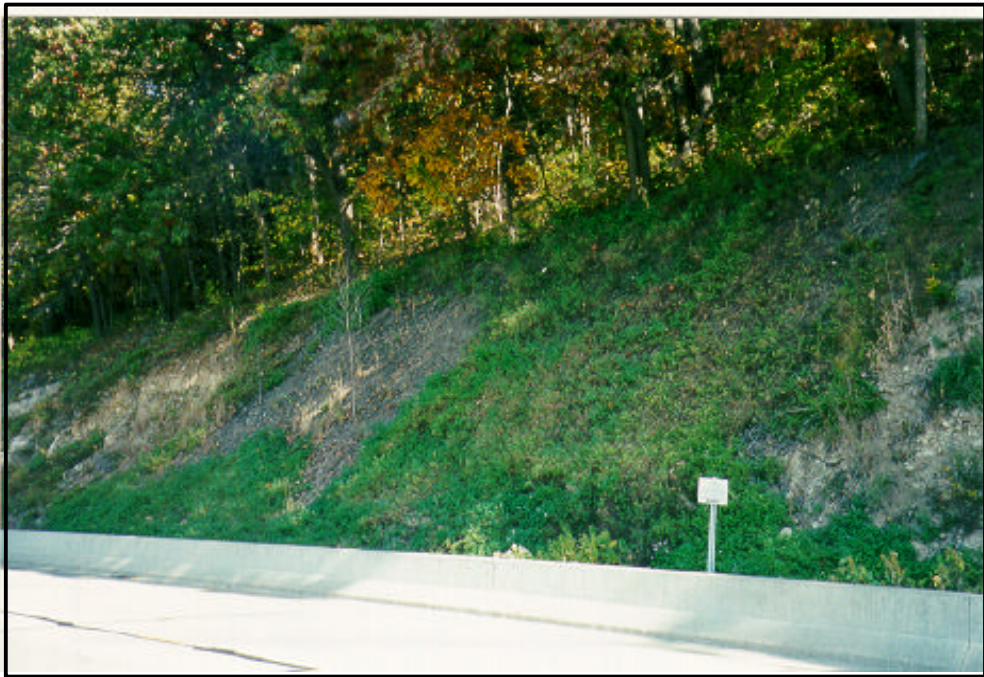
Vegetation cover, mostly crown vetch, was approximately 70% for this area, while approximately 30% of the area was sparse and partly washed out. An accumulation of topsoil was noted at the base of the slope, however the slope still had topsoil on most of it, as exposed rock was mostly non-existent. The “washed out” area still had topsoil in place. A couple of small trees have started growing.

The netting from the erosion mat was still in place, possibly helping “hold” everything in place (topsoil, vegetation, rocks). It was noted that the untreated area to the north of this test site had more rocks accumulate at the base of the slope.

Print 10. View of the vegetation on the J.K. Structure, August, 1999. Notice the washed out area to the north (left) of the J.K. Structure.

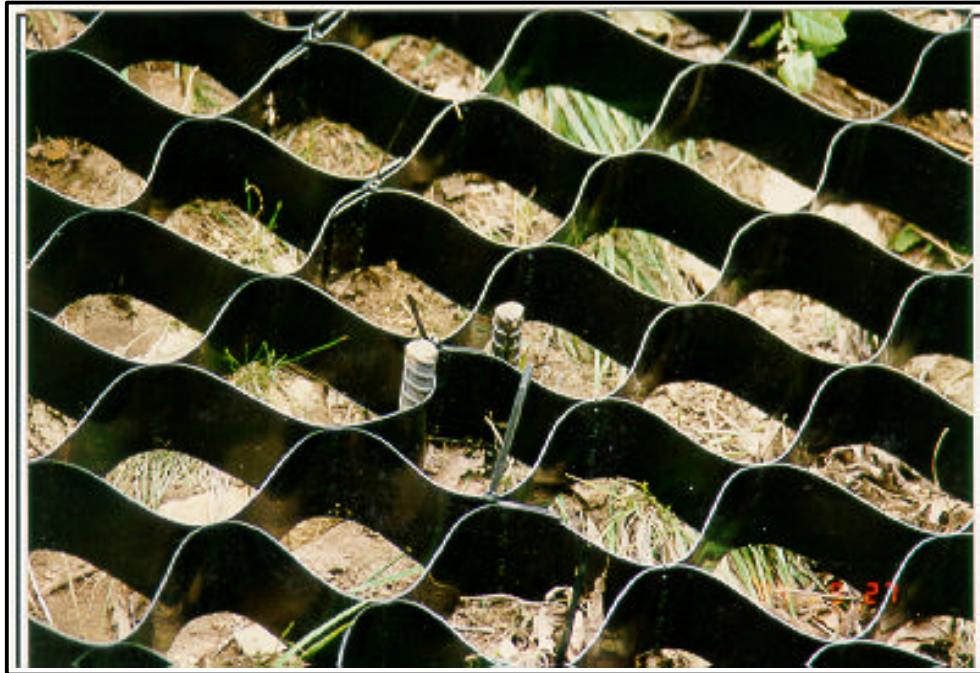
Print 11. Close-up view of the Geoweb Cellular Confinement System.

Geoweb Cellular Confinement System, manufactured by Presto Products Company, Appleton, WI., is an expandable plastic mesh that is stretched down the face of the slope (Print 11, page 19). The individual cells are 10.16 cm (4 in.) deep and 30.48 (8 in.) across. The Geoweb Confinement System came in 2.4 m x 6.1 m (8 x 20 ft.) sections. The Geoweb was anchored at the top of the slope using pins made from # 8 rebar and 12.5 mm rebars. The 12.5 mm rebar was attached along the top edge of the Geoweb using plastic ties, then anchored down using 0.91 m (3 ft.) pins (# 8 rebar). The Geoweb was then expanded downward and anchored using 33 pins per panel. It was found that a 2.4 m (8 ft.) steel fence post cut in half, with a “T” welded on, held better than the round # 8 rebar in the slope. Originally, the Geoweb supplier intended to use wooden stakes to anchor the Geoweb, but because of the rocky slope, steel pins were used. Because of concerns by the supplier that the Geoweb may not stay in place on the relatively steep

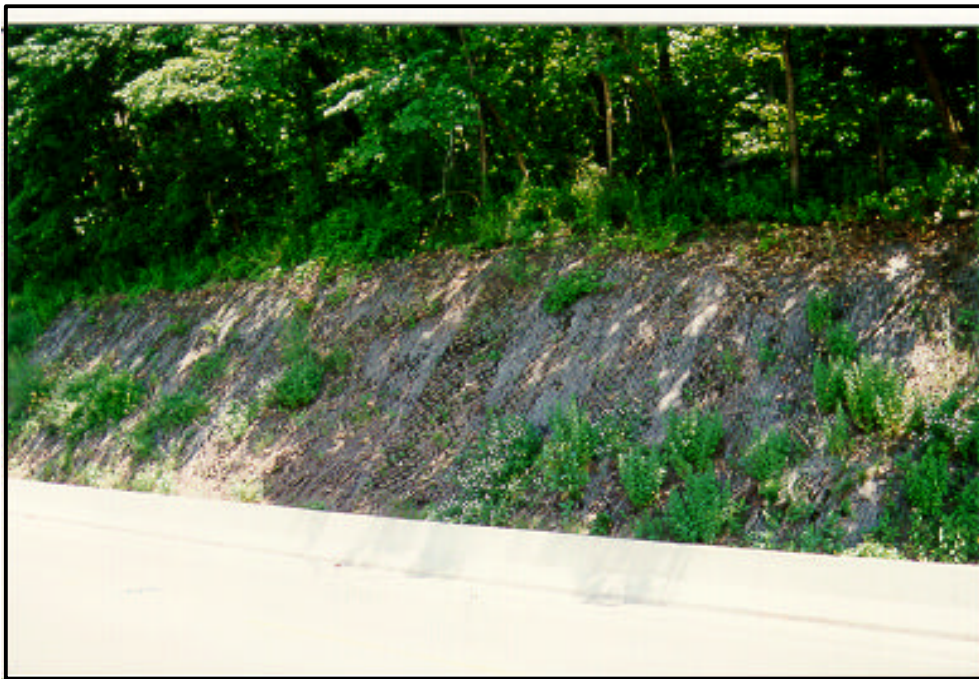
80-85% of this area had no vegetation. There were some areas of crown vetch, a few rye and other grasses and various weeds growing.

Print 14. View of vegetation on Geoweb, June 27, 1996, almost two years after installation.

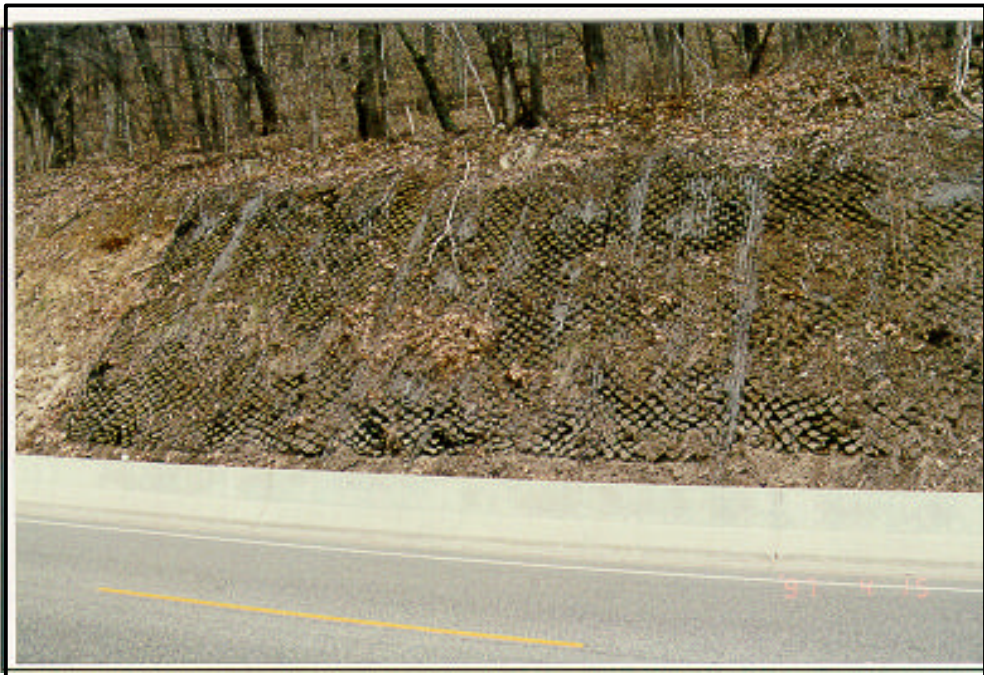
Loss of topsoil from the Geoweb cells was noted throughout the entire Geoweb area. Approximately 50% of the topsoil from the individual cells was lost, mainly on the top half of the slope. The section of Geoweb without the erosion mat had a loss of 50 - 75% of the topsoil. There was an isolated area with 100% loss of topsoil. It was also noted that there were areas where the topsoil appeared to have eroded from underneath.

Print 16. Geoweb, April 15, 1997.

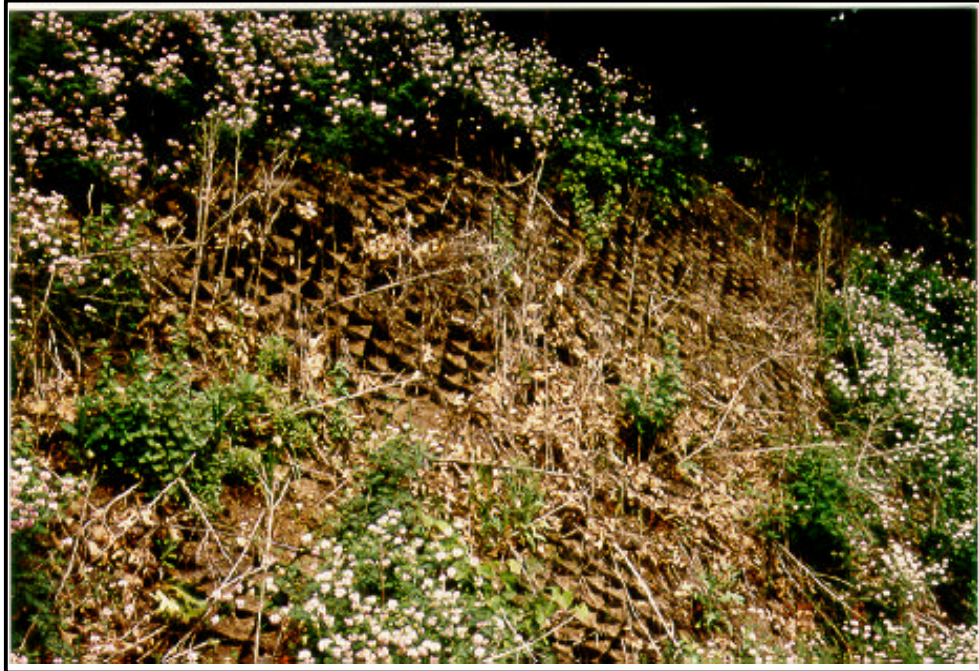
Approximately 50-60% covered with vegetation.

Print 17. Geoweb, June 17, 1998 showing sparse vegetation cover.

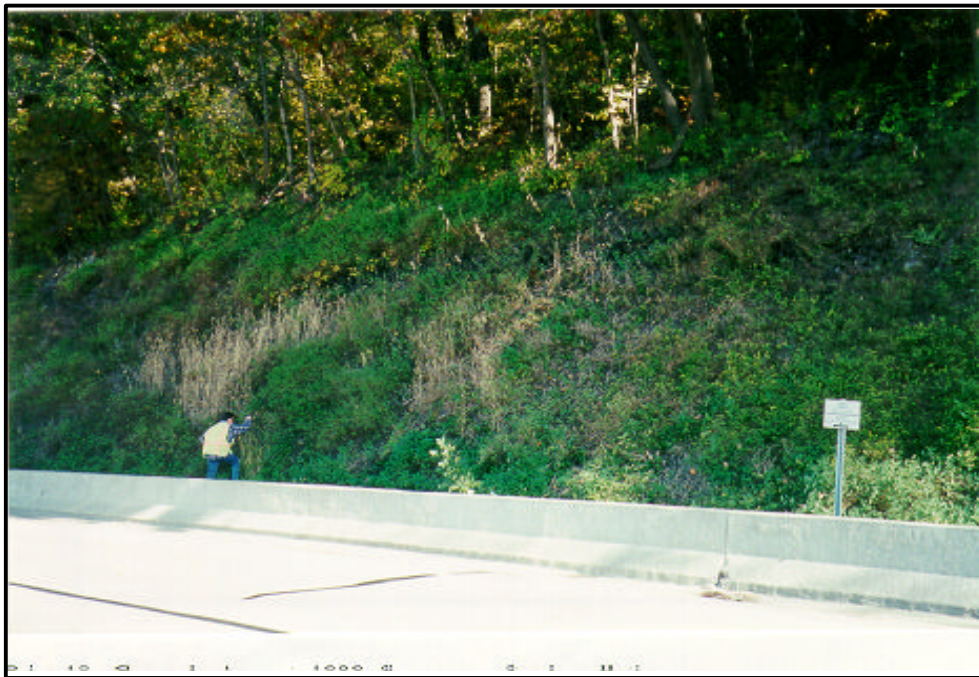
Approximately 90% of this area had some form of vegetative cover, mostly crown vetch, sweet clover and fox tail. Although it was about 90% covered with vegetation, the cover was quite sparse upon closer inspection. A couple of washed out areas were observed exposing bare rock. Only one to two 8-10” rocks were observed at the base of the slope, much less than the control area and also less than the J.K. Structure. The cellular webbing was observed to be quite distorted, probably from gravity trying to “pull” the soil-filled cells down the slope. It was also noted that the cells still containing topsoil had denser vegetative growth than the cells which were bare and void of topsoil due to erosion etc. A lot of topsoil was still present in the cells.

Print 18. Geoweb, August, 1999, five years after installation.

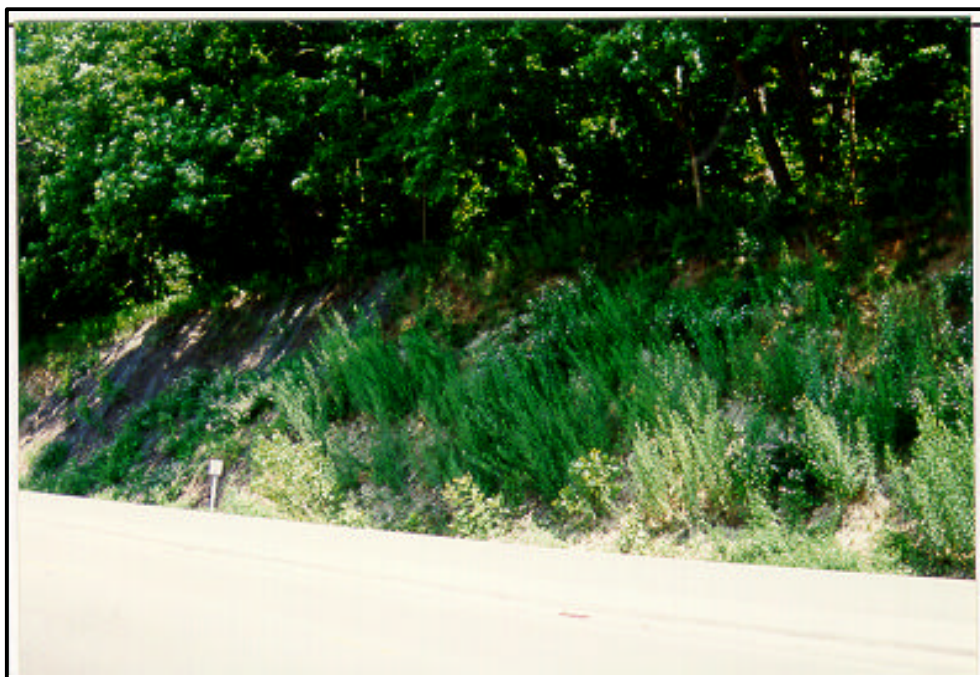
Appeared to be 70% covered with vegetation, but the vegetation consisted mainly of sweet clover which is tall and coarse, so actual ground cover was less because individual plants are spaced farther apart. There was also some crown vetch and other grasses growing.

Print 20. View of vegetation on J.K. Structure to the left, control section right 2/3rd of photo, June 27, 1996.

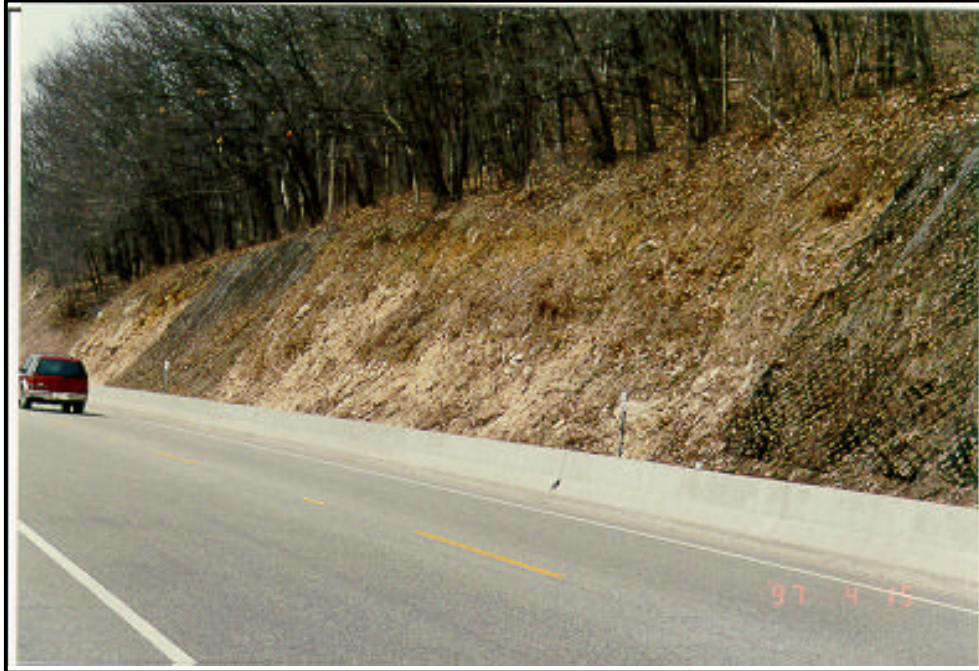
The top 10 - 15 ft. of the slope showed some loss (< 25%) of the topsoil. The rest of the J.K. Structure appeared to be holding the topsoil.

Areas of erosion were observed in the control section. The locations of these areas as measured from the south end of the control area are:

+25 - 78 ft. – erosion from mid-slope (10-12' from bottom of slope) to bottom of slope.

+78 - 100 ft. – erosion started 10' from top of slope to bottom of slope.

Bottom of slope had been cleaned out with yumbo, possibly earlier that spring. At +95 - 100 ft., an area of the erosion was approximately 2 ft. deep.

+100 ft. to end of control – Some sloughing of slope material had occurred.

Print 21. Geoweb, Control and J.K. Structure, April 15, 1997.

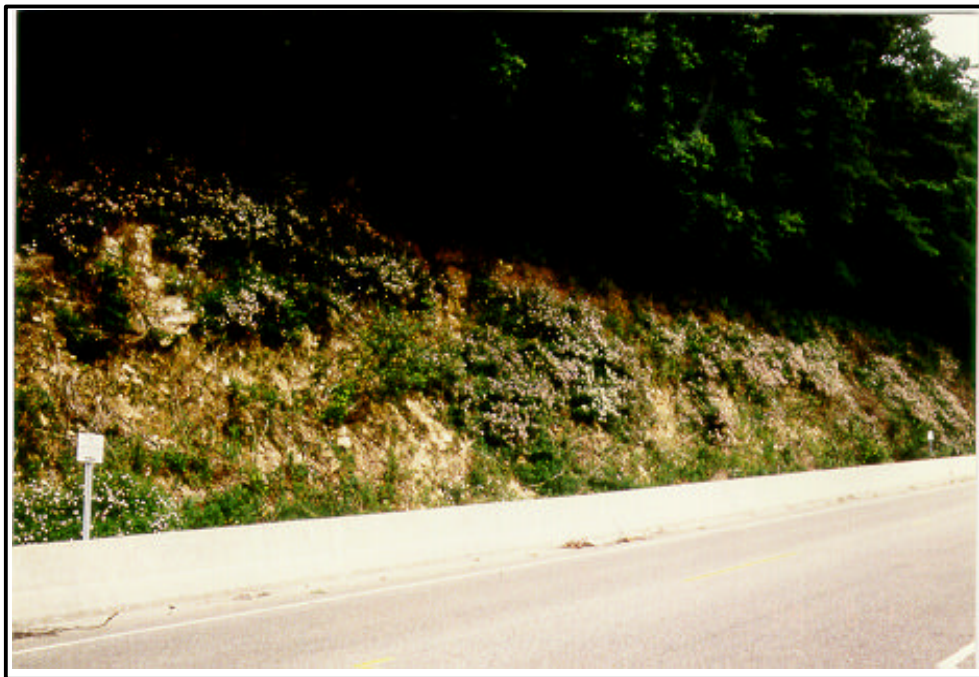
Approximately 30-40% covered with vegetation.

Print 22. Control Section, June 17, 1998.

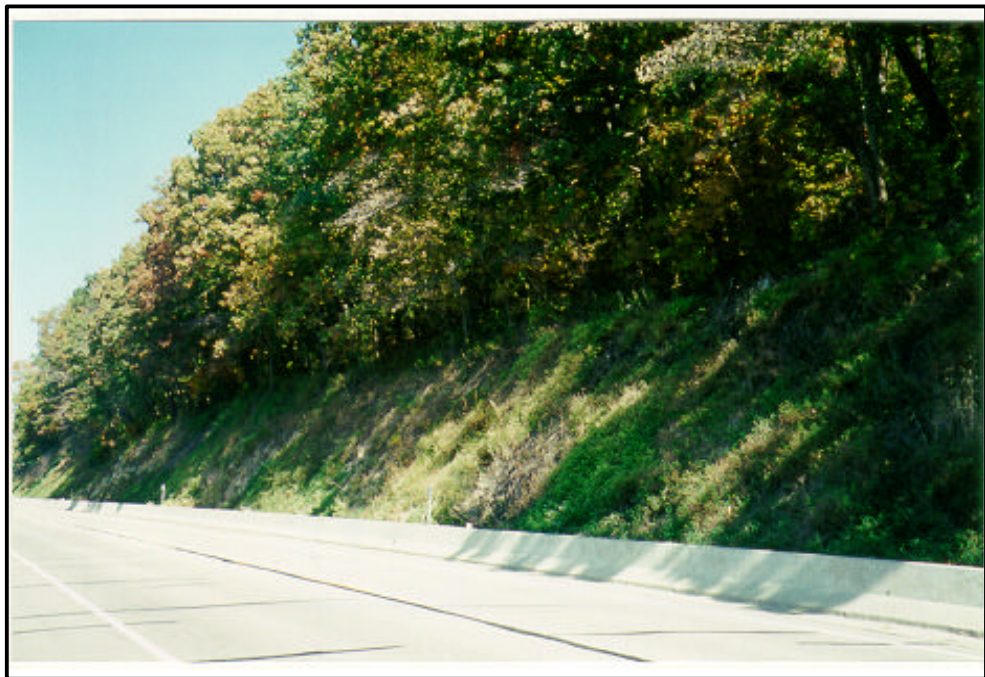
The control area had approximately 70% cover, mostly crown vetch, sweet clover and fox tail. The base of the control area had an accumulation of small rocks (6-15” in diameter) at the base of the slope. The accumulation of rocks at the base of the slope was largely absent from the J.K. Structure and the Geoweb areas.

Print 24. Geoweb, Control and J.K. Structure, August, 1999, five years after installation.
